Report on PolyMet Tailings Basin Geology and Proposed Engineering Controls

Paula Maccabee
Attorney for WaterLegacy
1961 Selby Avenue
St. Paul, MN 55104

J.D. Lehr
Professional Geologist
P.O. Box 217
Lutsen, MN 55612

Date: January 4, 2022

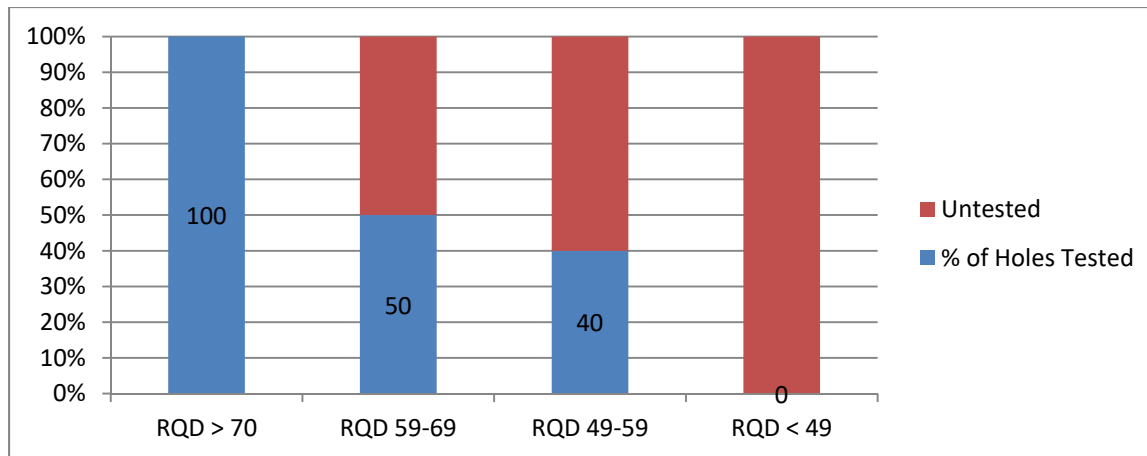
PACKER TESTING WAS BIASED BY NOT TESTING DRILL HOLES WITH MOST FRACTURED ROCK

Barr did not conduct packer testing within the most fractured intervals and conducted disproportionately fewer packer tests within drill holes where more fractured bedrock is present. This biased testing resulted in unrepresentative conclusions as to the amount of water that flows through bedrock at the tailings basin site. Although the Final EIS stated that the “geometric mean of hydraulic conductivity values . . . is 0.14 ft/day,” this “best estimate”⁴⁸ does not reflect unbiased testing. Even though packer testing did not fully encompass intervals with the lowest RQD's and excluded from packer testing drill holes with the lowest average RQD's, individual packer test results yielded hydraulic conductivities that varied by two orders of magnitude.⁴⁹

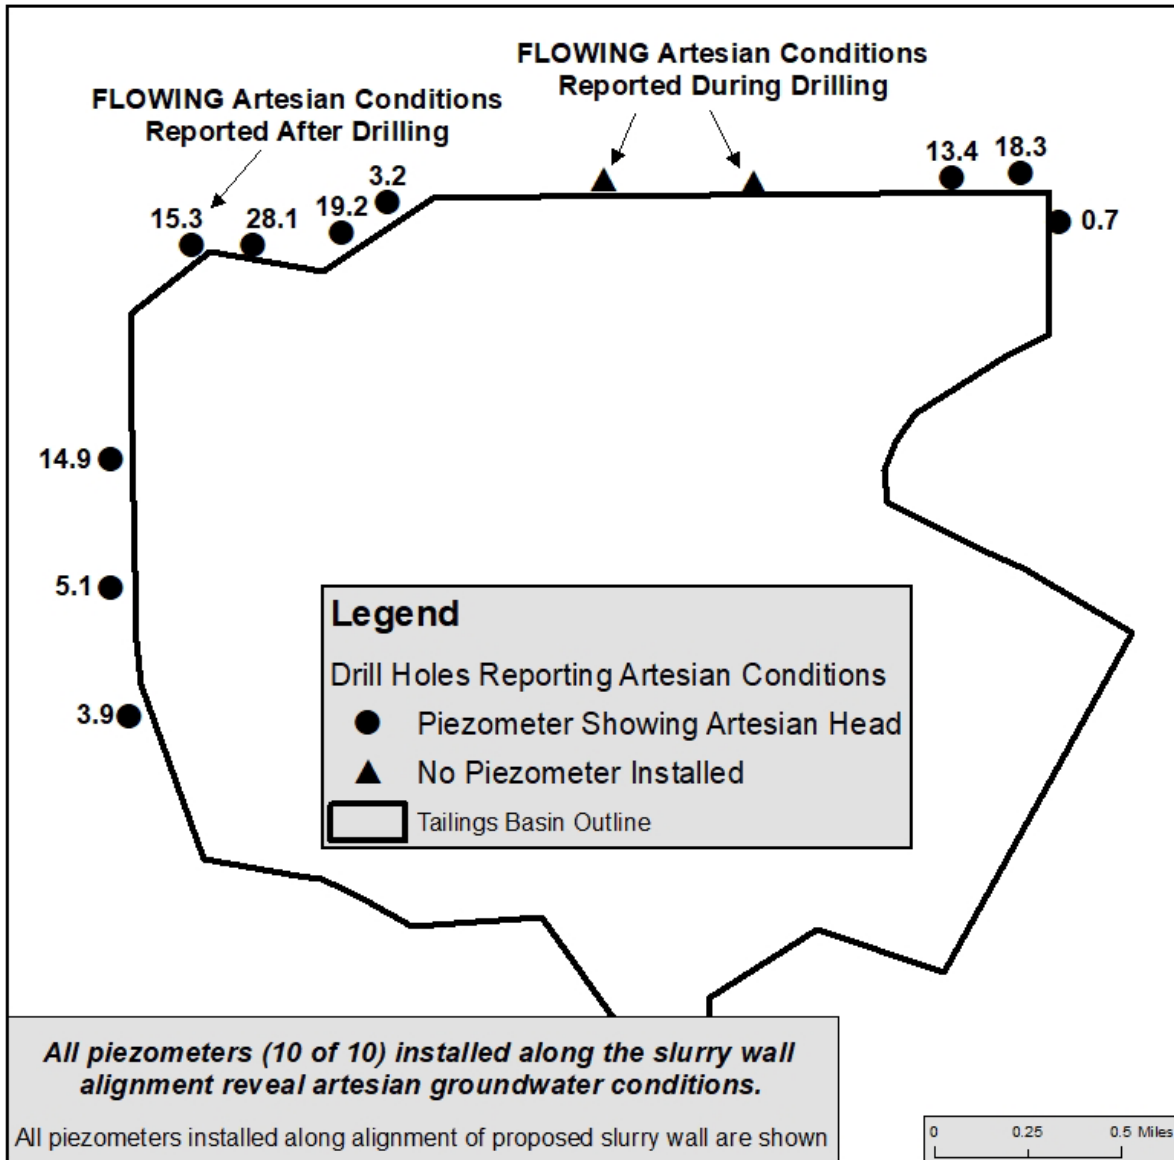
SUMMARY OF FIGURE 18. ARTESIAN GROUNDWATER CONDITIONS MAY PRECLUDE PROPOSED SLURRY WALL⁷¹

“Artesian groundwater conditions were encountered in several piezometers and drill holes during investigation, including one drillhole (R14-20) that encountered approximately 10-12 gallons per minute (gpm) of flow within the upper foot of the granite.”⁷²

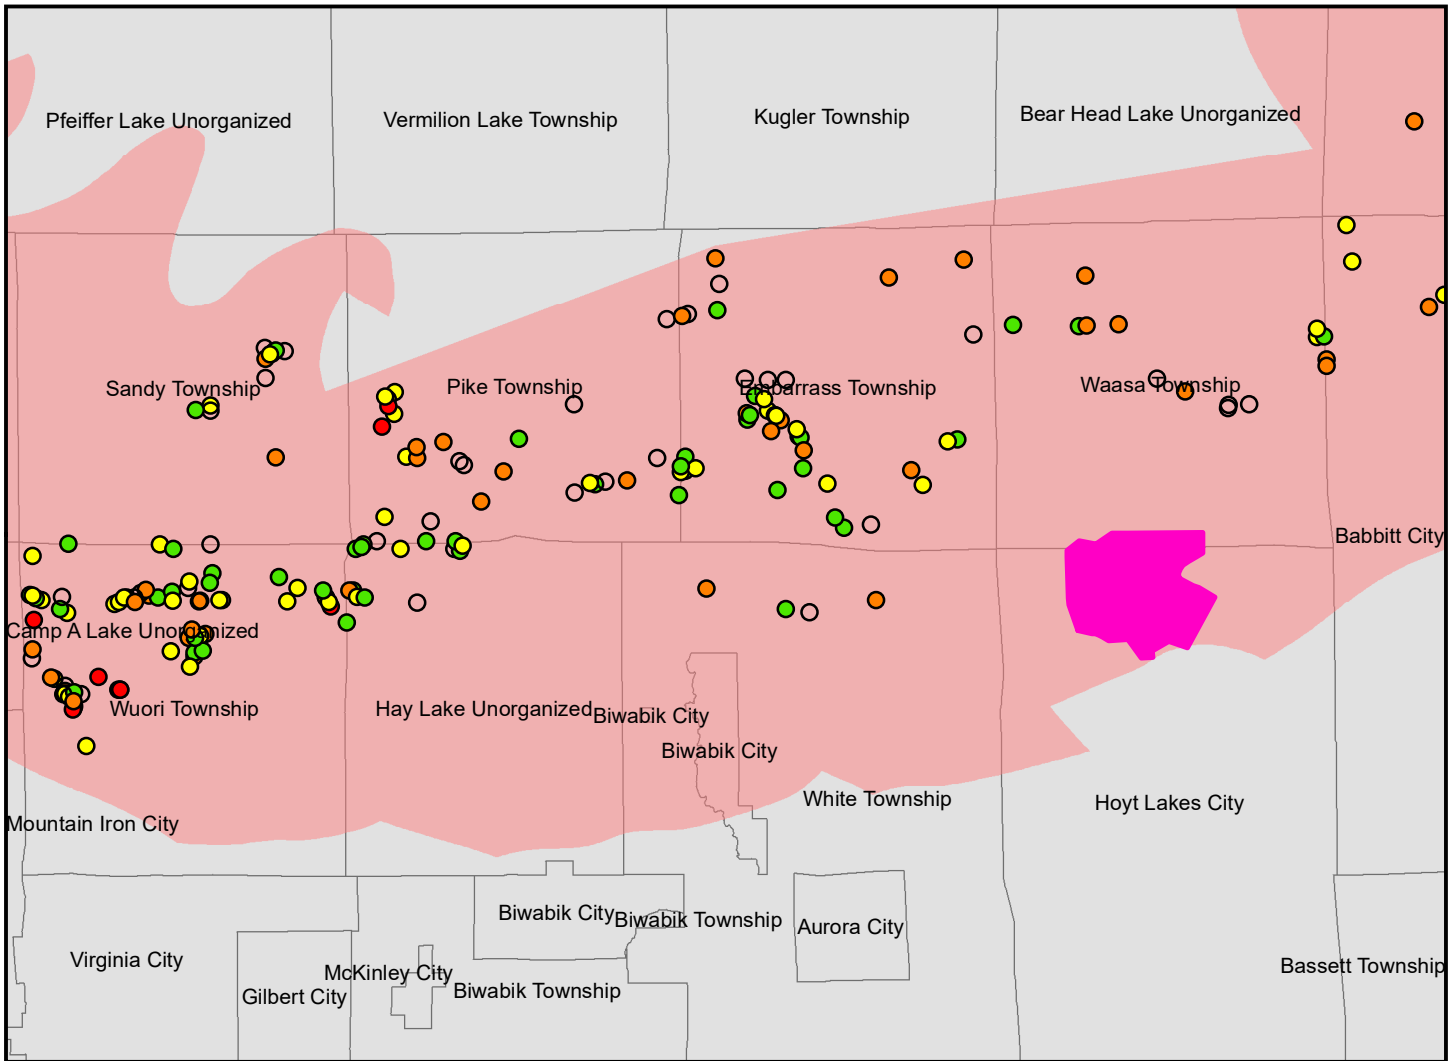
Evidence for significant groundwater flow through widespread interconnected bedrock fractures is provided by the thousands of residents of rural northeastern Minnesota that have drinking water in their homes. Figure 9 shows the locations of wells from the County Well Index³⁵ in the vicinity of the tailings basin completed in Giants Range Granite – the same bedrock unit that underlies glacial sediments at the tailings basin. The depths of wells completed in the Giants Range Granite vary from 20 to 640 feet deep (Figure 9). Fractures conveying enough water for domestic use were intersected at depths hundreds of feet into the bedrock within the Giants Range Granite in the vicinity of the tailings basin. Contrary to PolyMet’s claim, the local hydrogeology of the Giant Range Granite makes it highly likely that hydrologically significant fractures exist deeper than 10 feet into the bedrock at the FTB tailings site.

The pattern of wells shown above results from a combination of where people live and geology. No domestic wells exist in the Giants Range Granite in close proximity to the tailings basin and towards the southwest because this is mining company property. Gaps in well density elsewhere are due either to lack of residences or sufficient water was found in glacial aquifers or homes are connected to municipal water systems. Absence of wells on the map above does not indicate lack of fractured water-bearing bedrock.

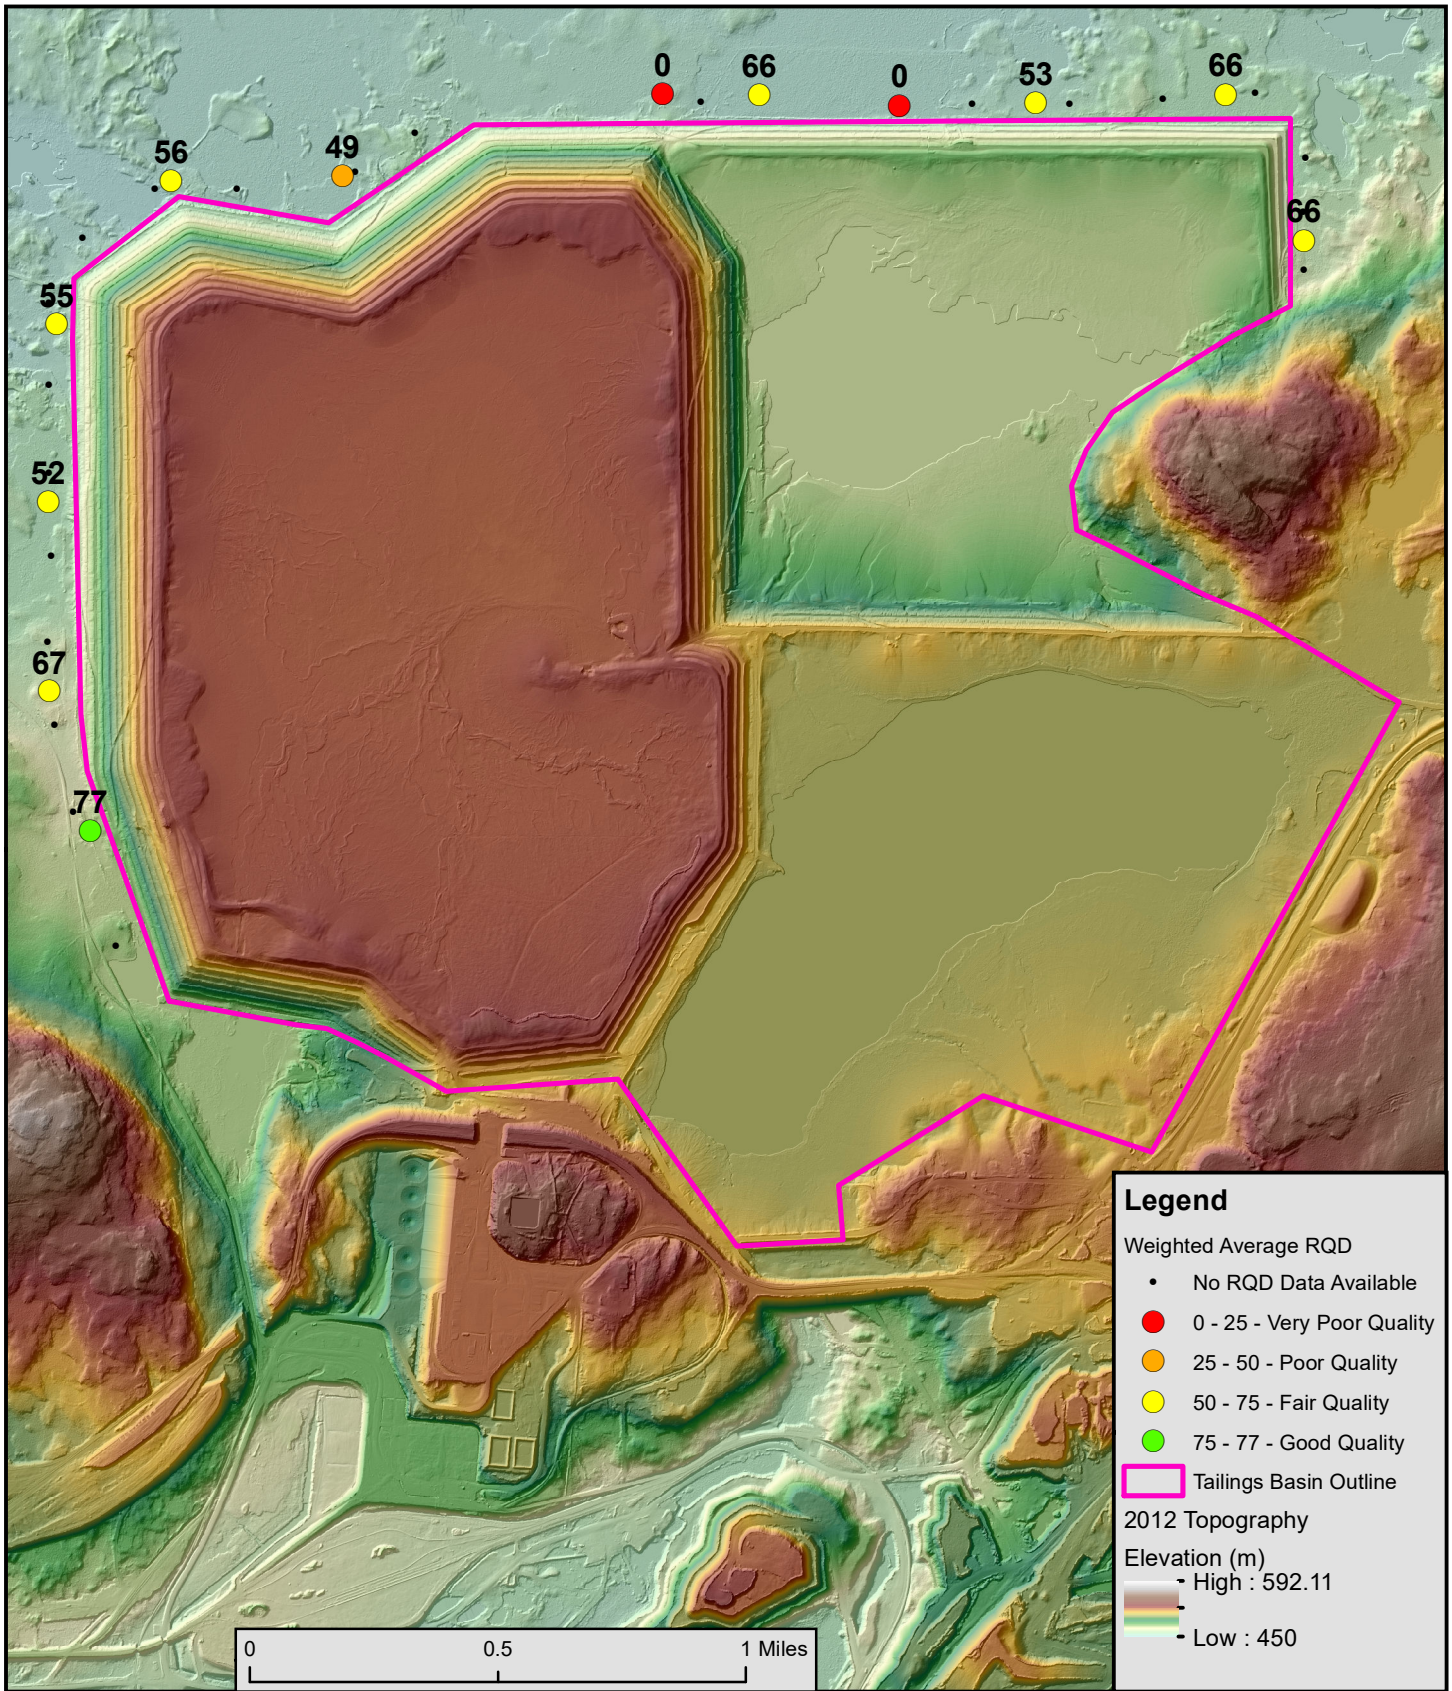
FIGURE 10. OVERALL WEIGHTED AVERAGE RQD*

Tables 5 and 6 include adjusted RQD values that account for the zero-core-recovery intervals and weathered zones inadequately characterized by PolyMet. Adjusted RQD values are also mapped on Figures 10 and 11. These values more accurately represent bedrock conditions encountered during the two 2014 drilling programs.

*RQD reported here is Adjusted RQD shown in Tables 5 and 6. Adjusted after accounting for intervals with weathered rock and zero core recovery.

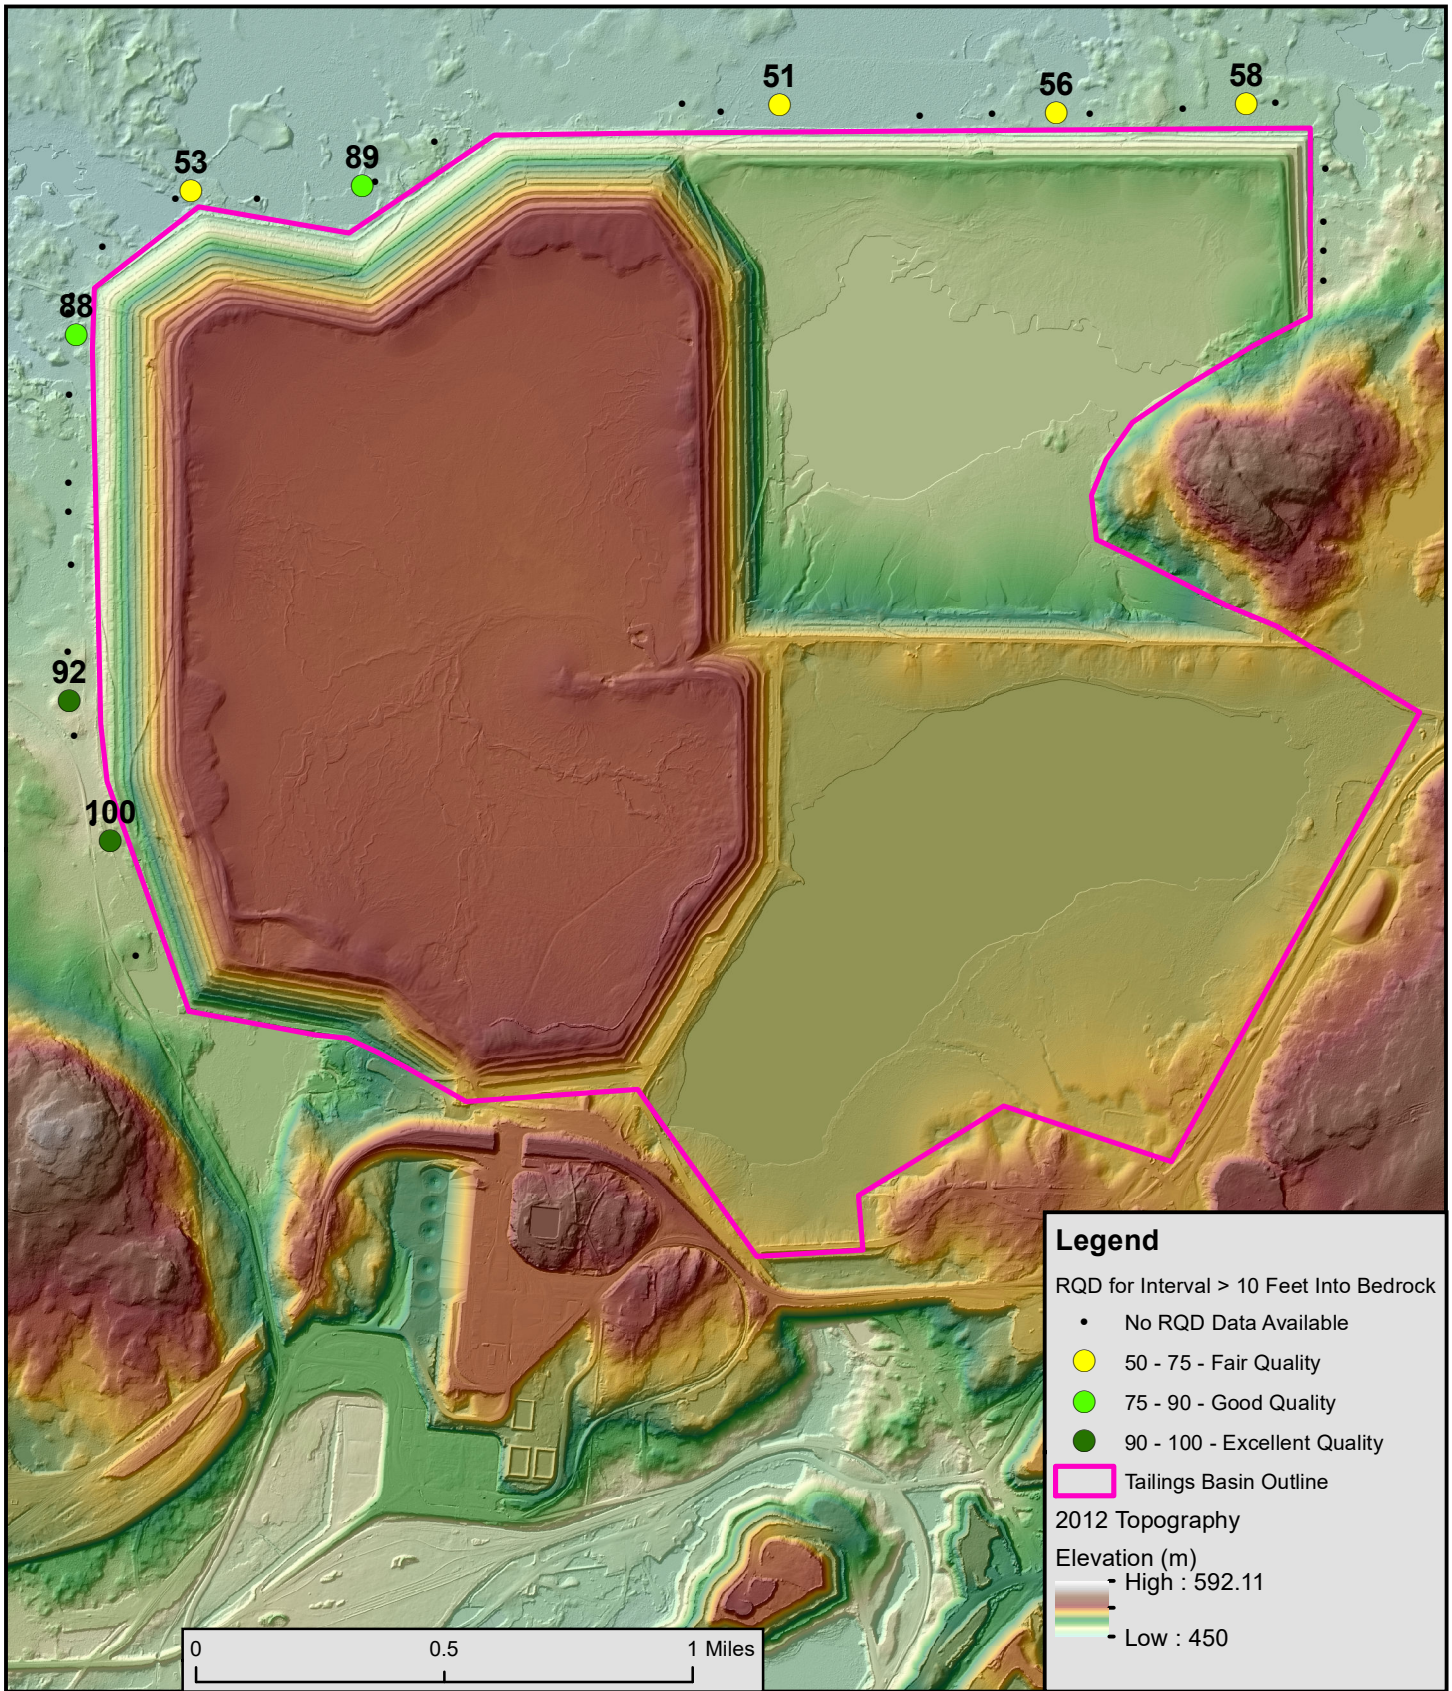
FIGURE 11. WEIGHTED AVERAGE RQD FOR INTERVAL > 10 FEET INTO BEDROCK*

*RQD reported here is Adjusted RQD shown in Tables 5 and 6. Adjusted after accounting for intervals with weathered rock or zero core recovery.

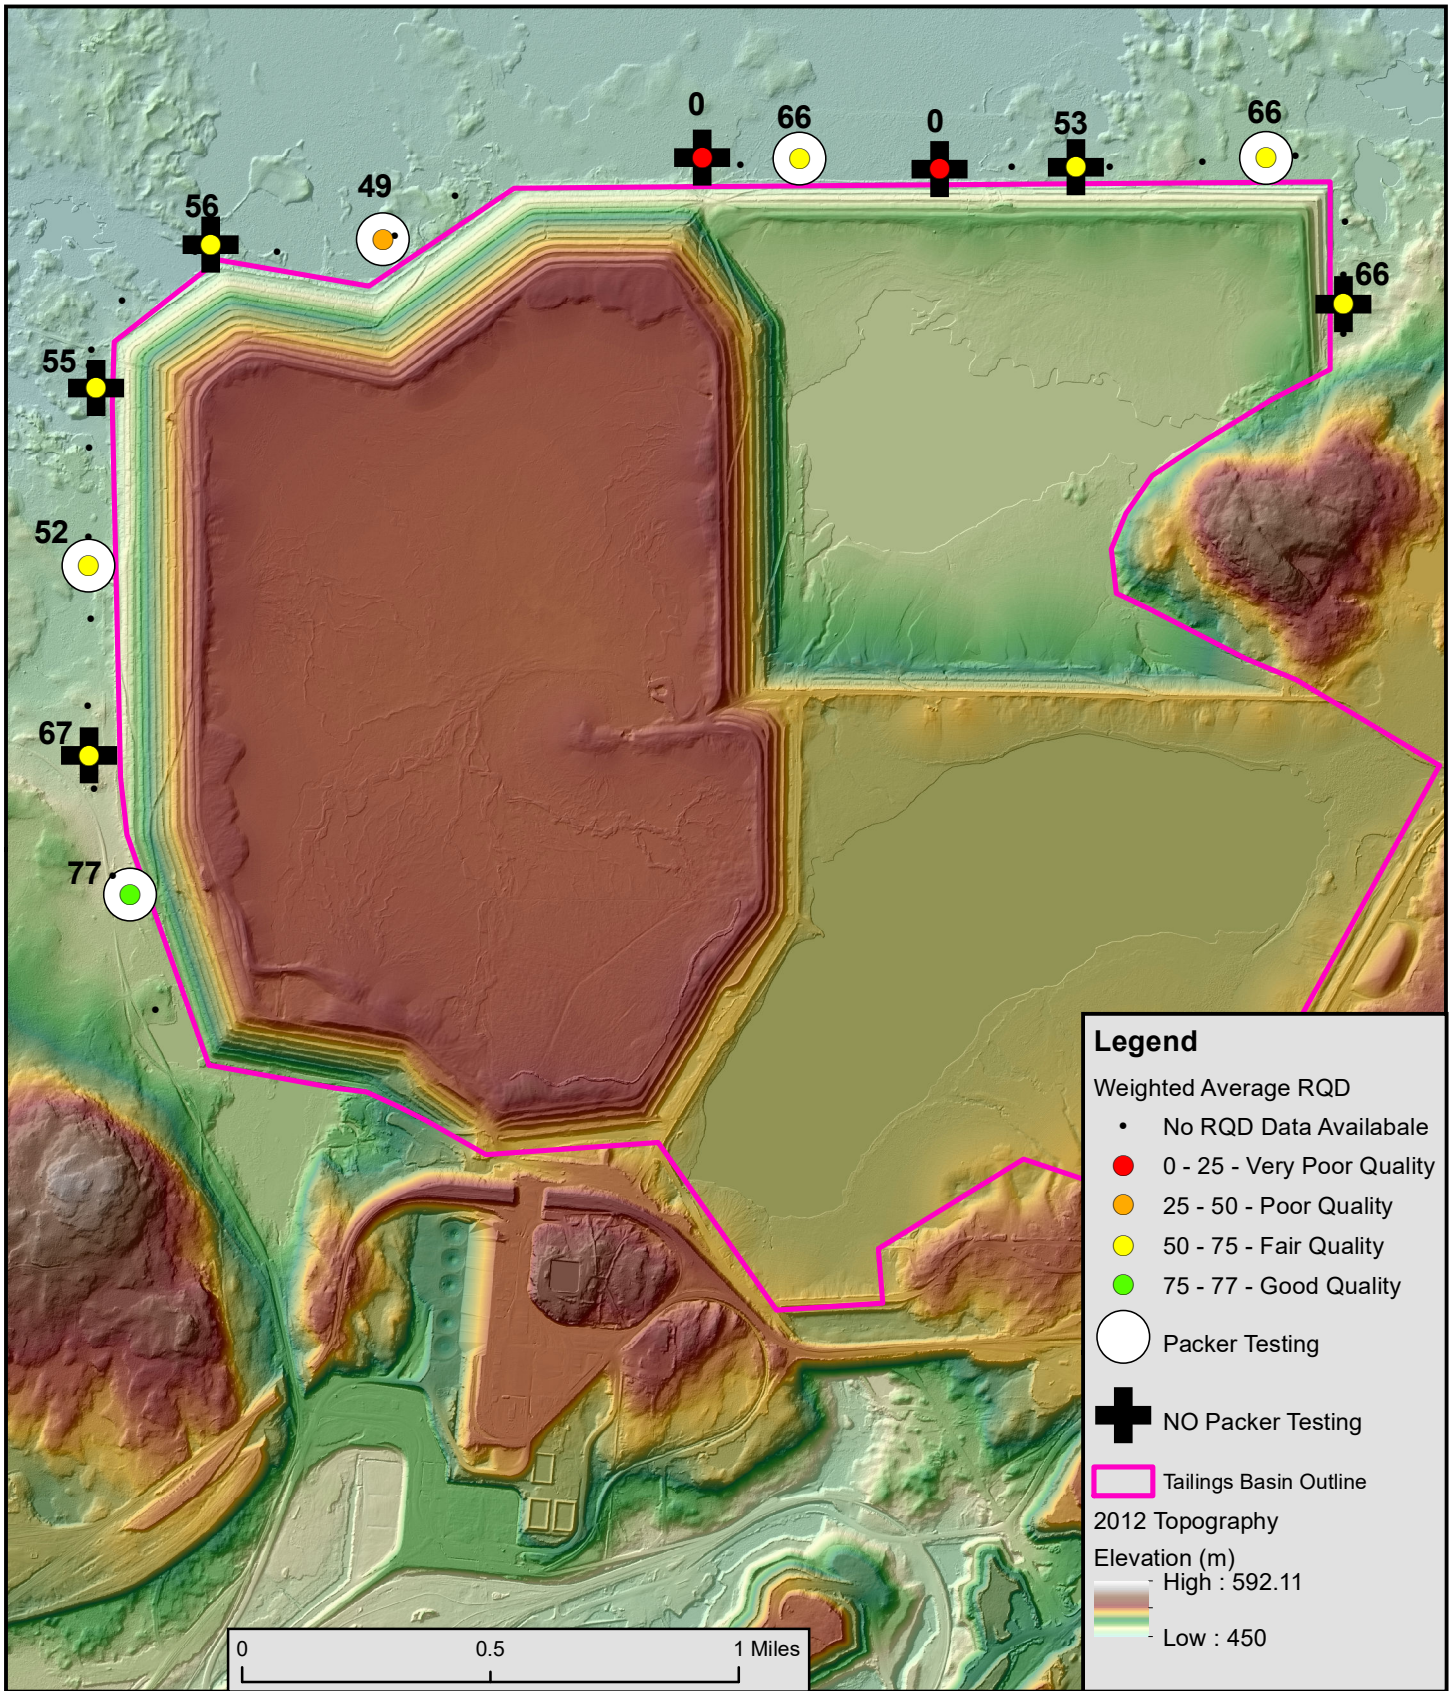
FIGURE 12. DRILL HOLES SELECTED FOR PACKER TESTING

Additional bias was introduced to the packer tests in deciding which drill holes to select for testing. Packer testing was carried out on all drill holes (100%) with weighted average RQD results⁴⁷ greater than 75 and on 2 of the 4 (50%) drill holes with RQD results in the 60's. Of the 5 drill holes with RQD results ranging from 49 to 59, only 2 (40%) were selected for packer testing and none of the drill holes with RQD's less than 49 were chosen (0%) (Figure 12). Notice that for that portion of the seepage capture system alignment immediately down-hydrologic-gradient from the FTB – the north side - packer testing was carried out in the two drill holes yielding the highest RQD results (66). Two drill holes with average RQD's of 0 and another of 53 were excluded from packer testing (Figure 12).

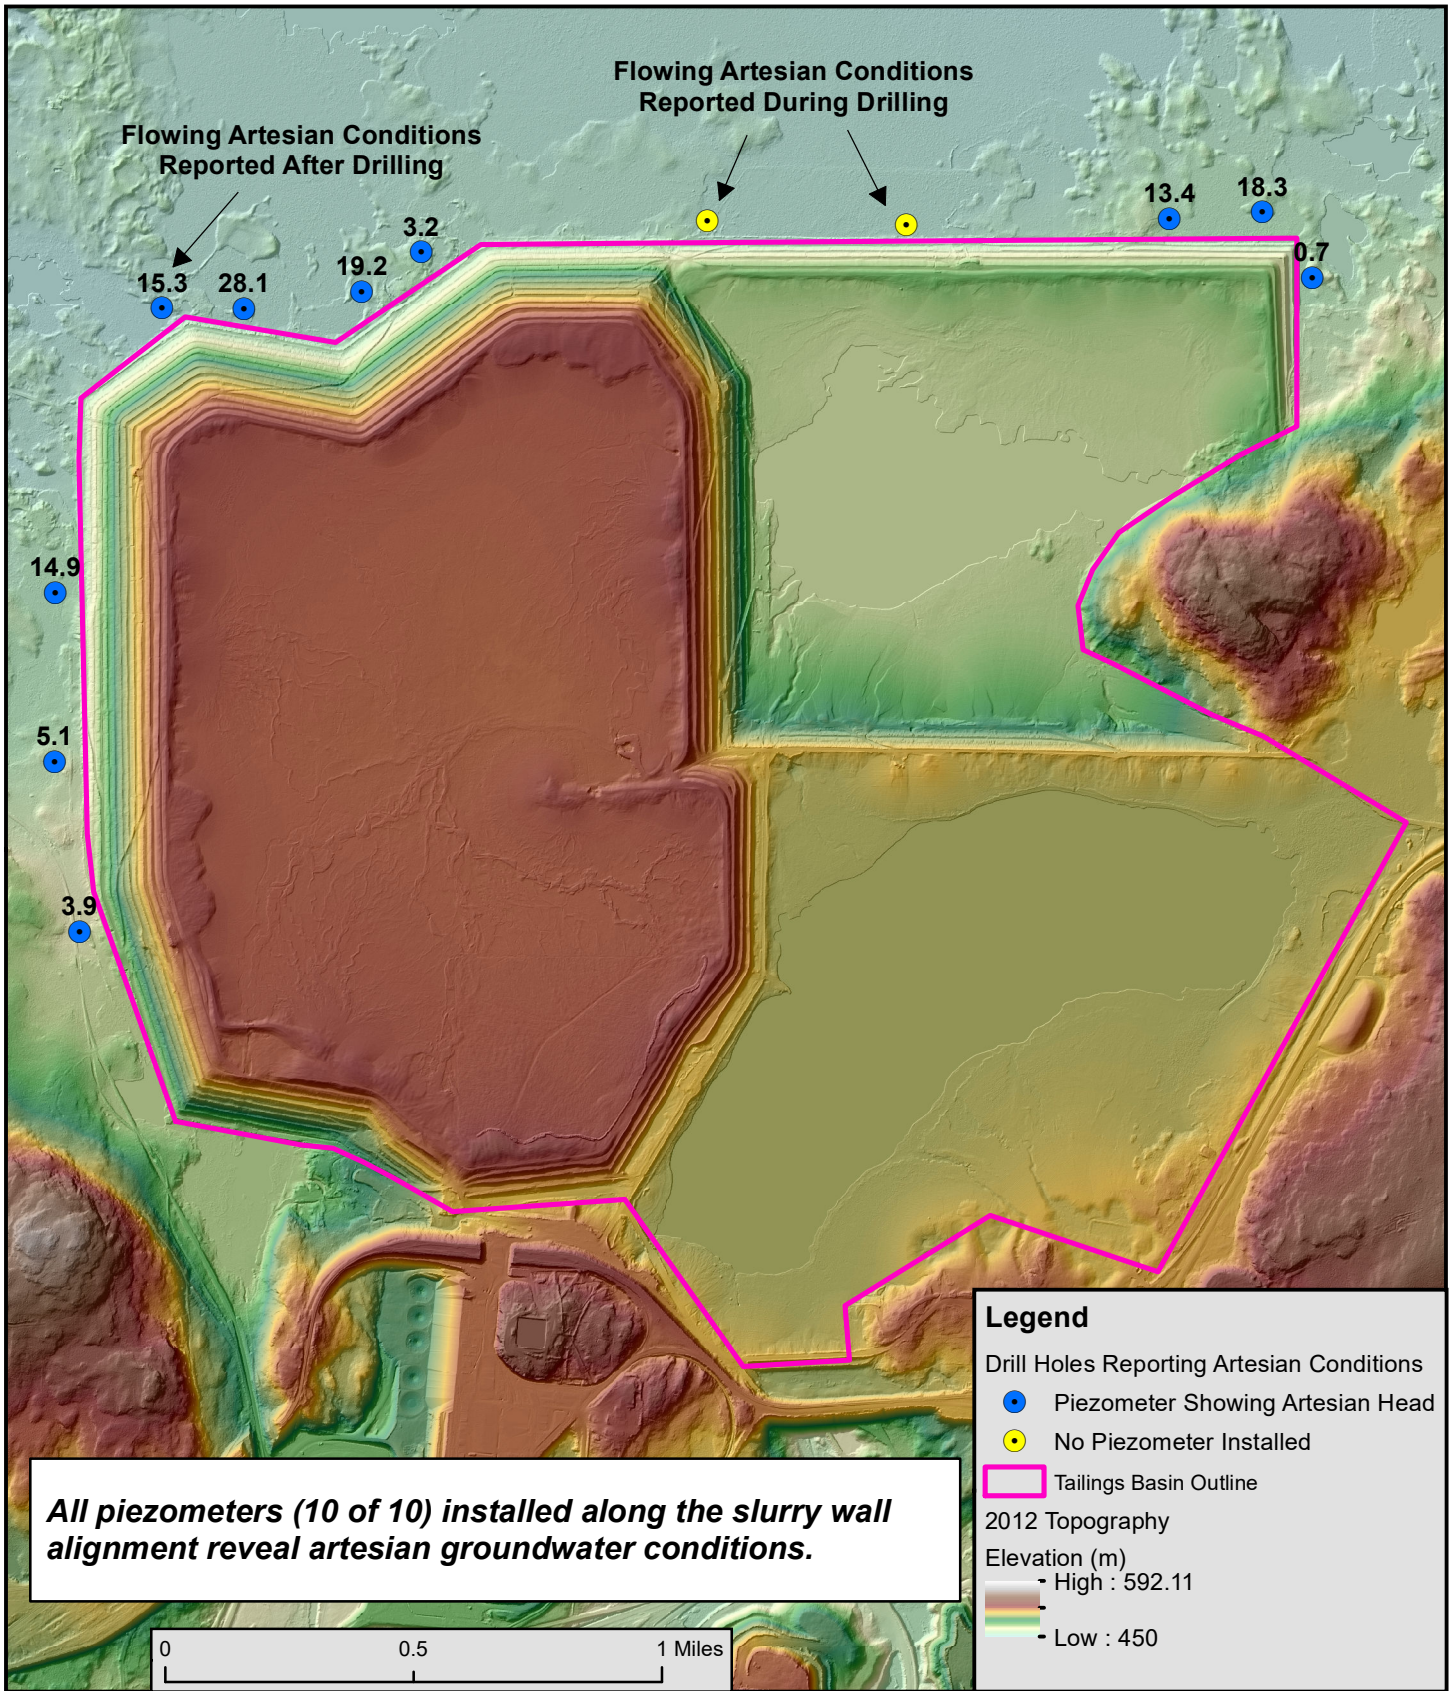
FIGURE 18. ARTESIAN GROUNDWATER CONDITIONS MAY PRECLUDE PROPOSED SLURRY WALL

All piezometers installed along alignment of proposed slurry wall are shown. Labels indicate artesian head (feet)

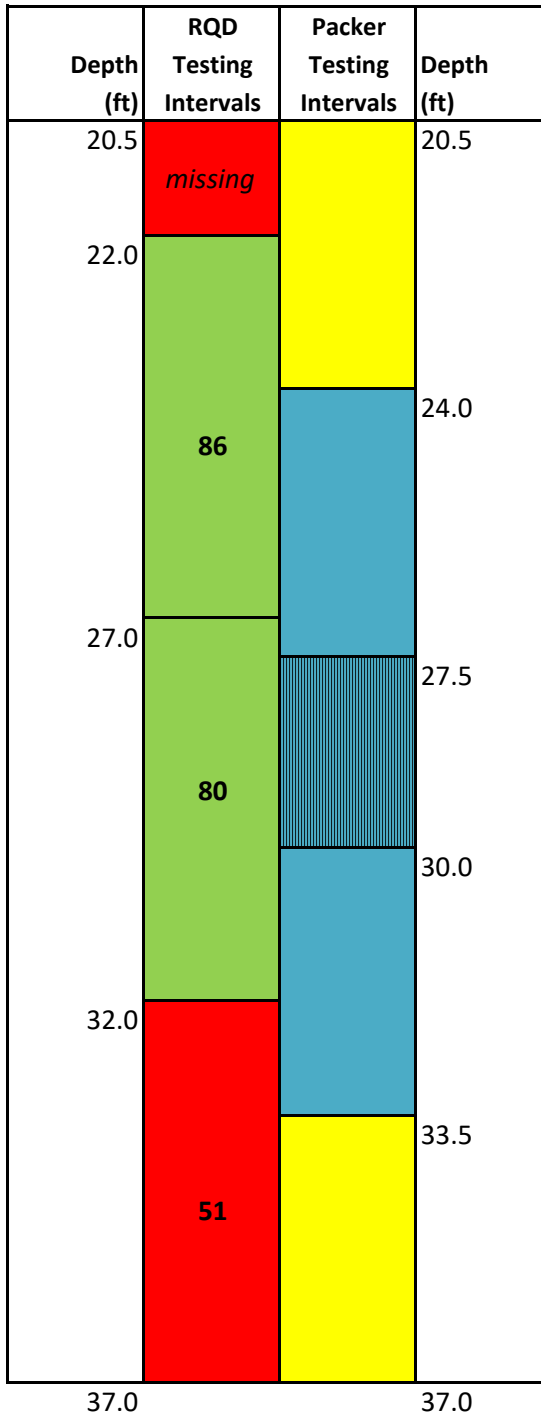
TABLE 10. PACKER TESTING INTERVALS AND RQD

GRANITE REPORTED AT 20.5 FEET
Shelby tube sample taken from 20.5 to 22 feet indicates either highly weathered or extremely fractured granite 20.5 to 22 feet.
