Report on PolyMet Tailings Basin Geology and Proposed Engineering Controls

Paula Maccabee
Attorney for WaterLegacy
1961 Selby Avenue
St. Paul, MN 55104

J.D. Lehr
Professional Geologist
P.O. Box 217
Lutsen, MN 55612

Date: January 4, 2022

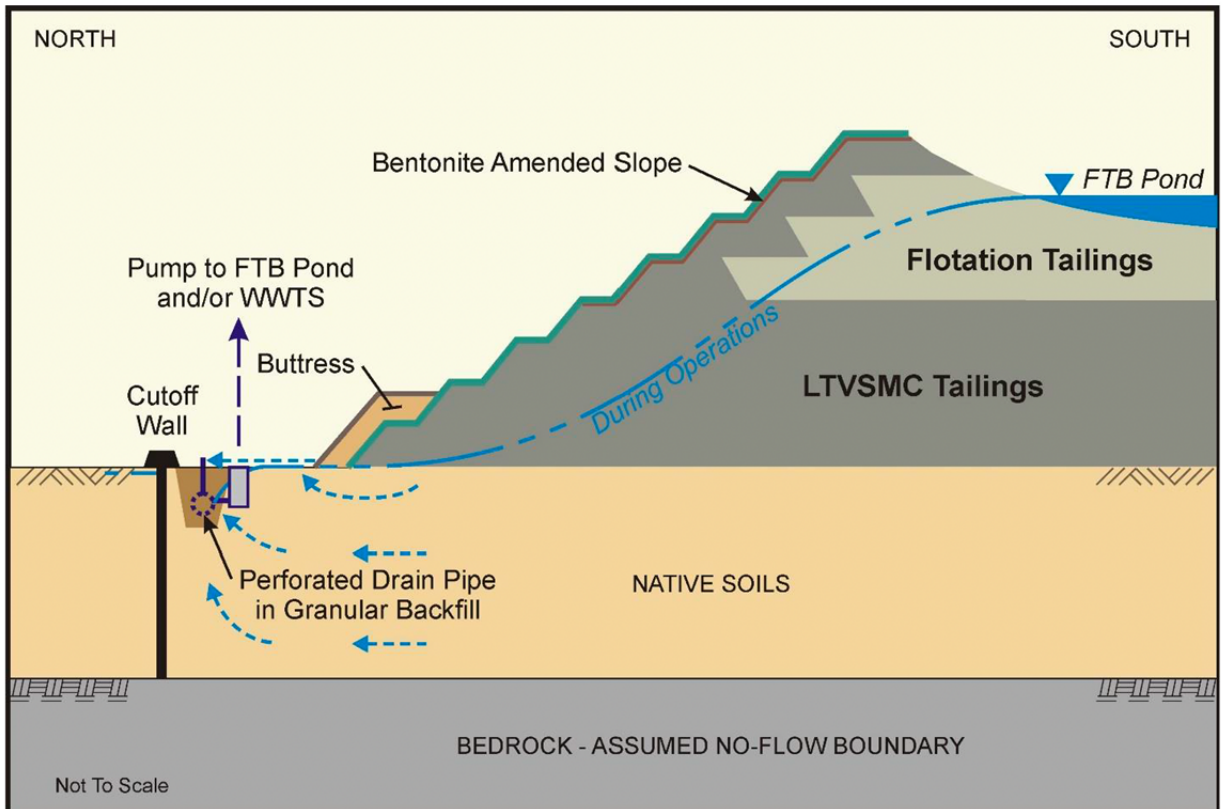
FIGURE 5. POLYMET’S SCHEMATIC DIAGRAM SHOWING ASSUMED NO-FLOW BOUNDARY WITHIN BEDROCK

The Geotechnical Report contained in the Permit to Mine Application arrives at the conclusion that only the upper 10 feet of bedrock contains a fracture density significant to groundwater flow and that below that zone bedrock fractures are so insignificant to groundwater flow that “*the bedrock* [beneath and surrounding the tailings basin] *acts as a no-flow boundary*” (Figure 5).^{27, 28} As explained in more detail in Section 5, testing data derived from the 2014 drilling programs at the tailings basin do not support PolyMet’s assumed “impermeable” and groundwater “no-flow” attributes of the bedrock at the tailings basin.

Note: this figure does not show the slurry/cutoff wall “keyed” into bedrock.

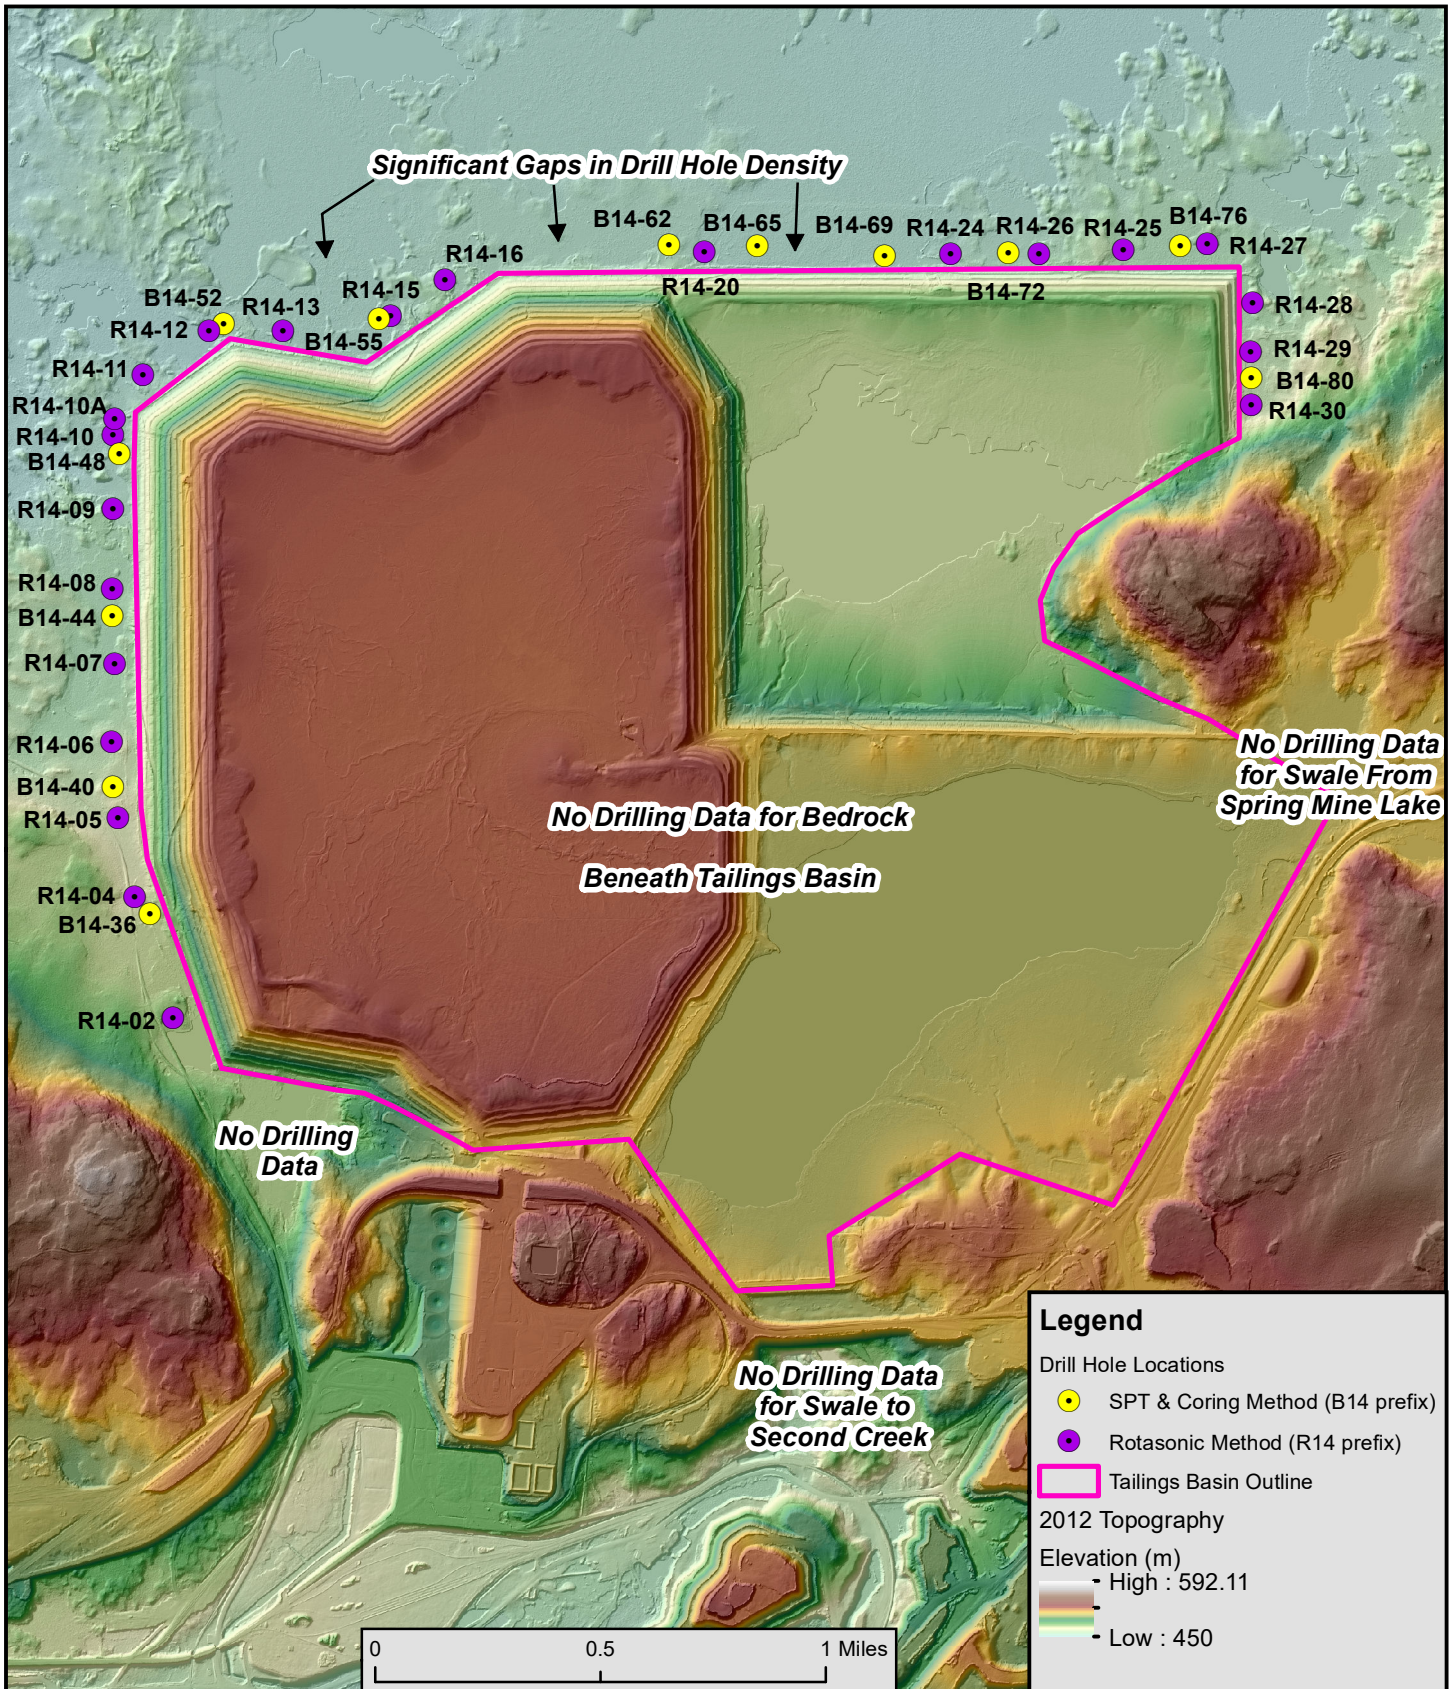
FIGURE 6. DRILL HOLE LOCATIONS

arithmetic.^{31, 32} Figure 6 shows the locations of the 2014 drill holes that are the basis for the Geotechnical Report as well as this report. Additional holes were drilled at the tailings basin but they were either not drilled deep enough or in the right locations to encounter bedrock. The drill holes discussed below (Tables 1 to 4) were drilled close to the proposed alignment of the tailings basin seepage capture system making them most relevant to discussing the relationship between the efficacy of the proposed seepage capture system and subsurface geology.

Gaps in the distribution of drill holes along the northern margin of the tailings basin (Figure 6) are explained in the Geotechnical Report as resulting from site access constraints. Along the northern perimeter of the tailings basin a total of 7 of the proposed 30 Rotasonic drill holes⁷⁴ were not drilled because “the proposed locations were not accessible”⁷⁵ “due to open water conditions”.⁷⁶

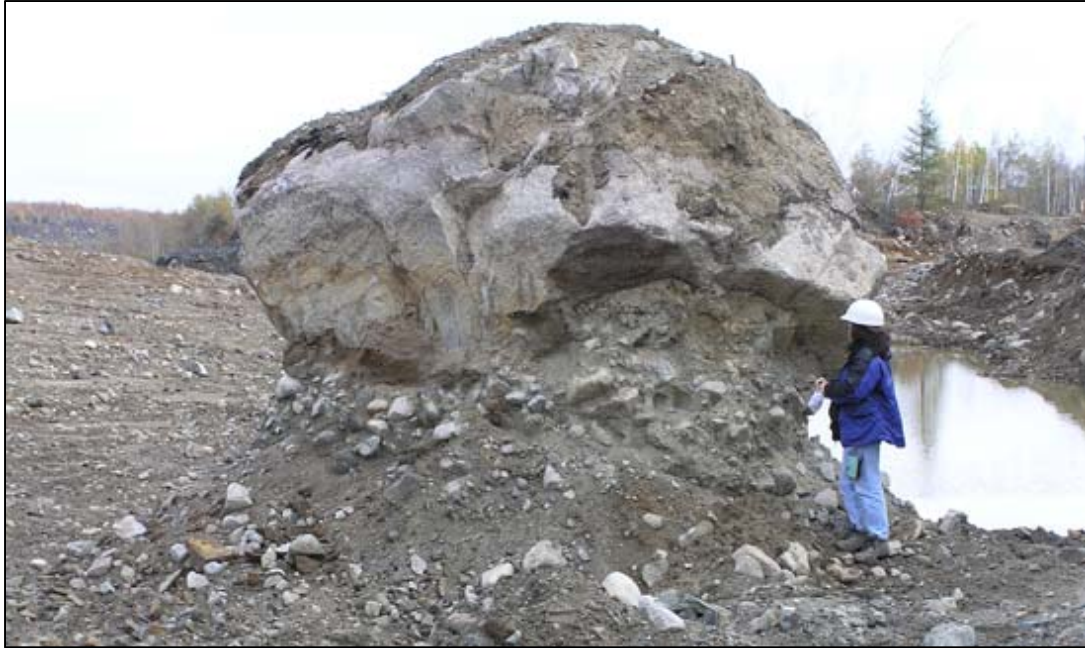
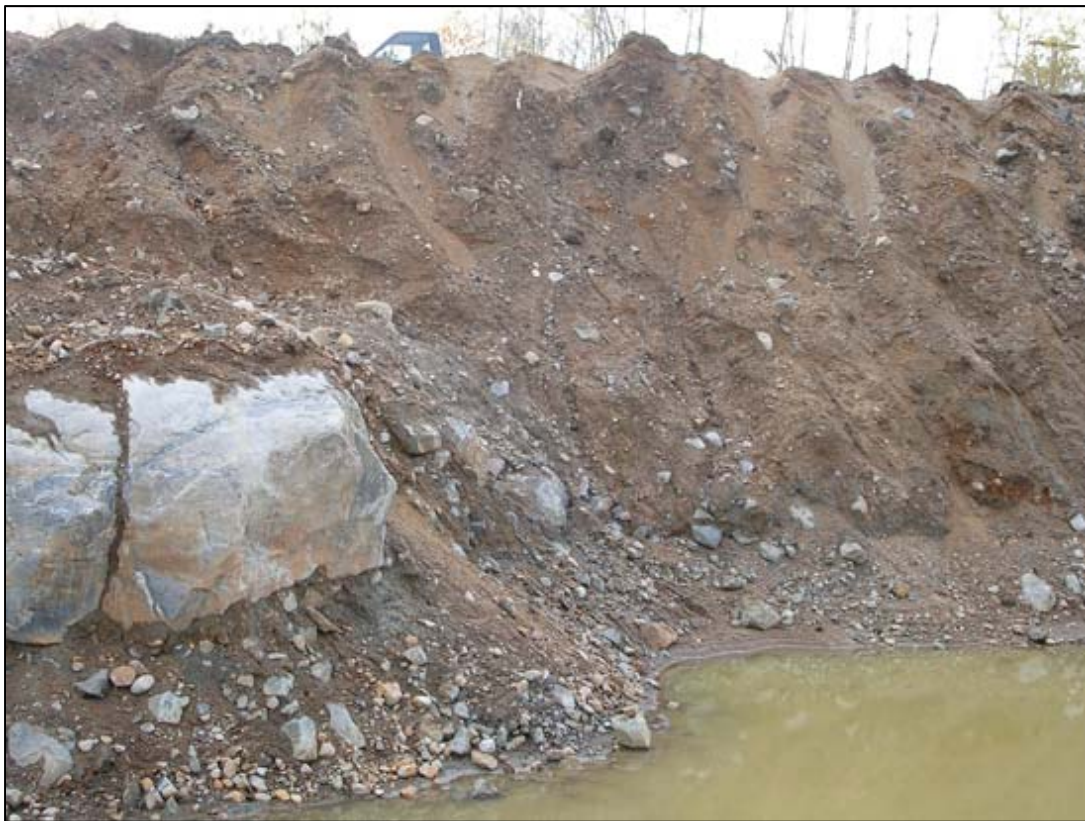
The Geotechnical Report describes the glacial till on the FTB site to contain boulders up to 4 feet in diameter.⁵⁴ However, it is known from the geologic literature⁵⁵ and experience that boulders significantly larger than 4 feet in diameter commonly occur within glacial sediments in the immediate vicinity of the FTB. Figure 14 shows boulders much greater than 4 feet in diameter at the Peter Mitchell Mine site 7.5 miles to the east of the FTB. Boulders of the size shown in Figure 14 also exist at the FTB site. During my field work on the LTV property, I have seen boulders on the land surface as large as my Jeep.⁵⁶ The boulder-rich nature of the glacial sediments in the vicinity of the FTB is an extraordinary geologic condition that I rarely encountered beyond the eastern Mesabi Range and parts of the adjacent Superior National Forest.

FIGURE 14. LARGE BOULDERS AT PETER MITCHELL MINE. Note pickup truck at top of bank for scale in second photo. *Source: Supplemental materials contained in Jennings, C.E., and Reynolds, W.K., 2005 Surficial geology of the Mesabi Iron Range: Minnesota Geological Survey Miscellaneous Map M-164, scale 1:100,000.*

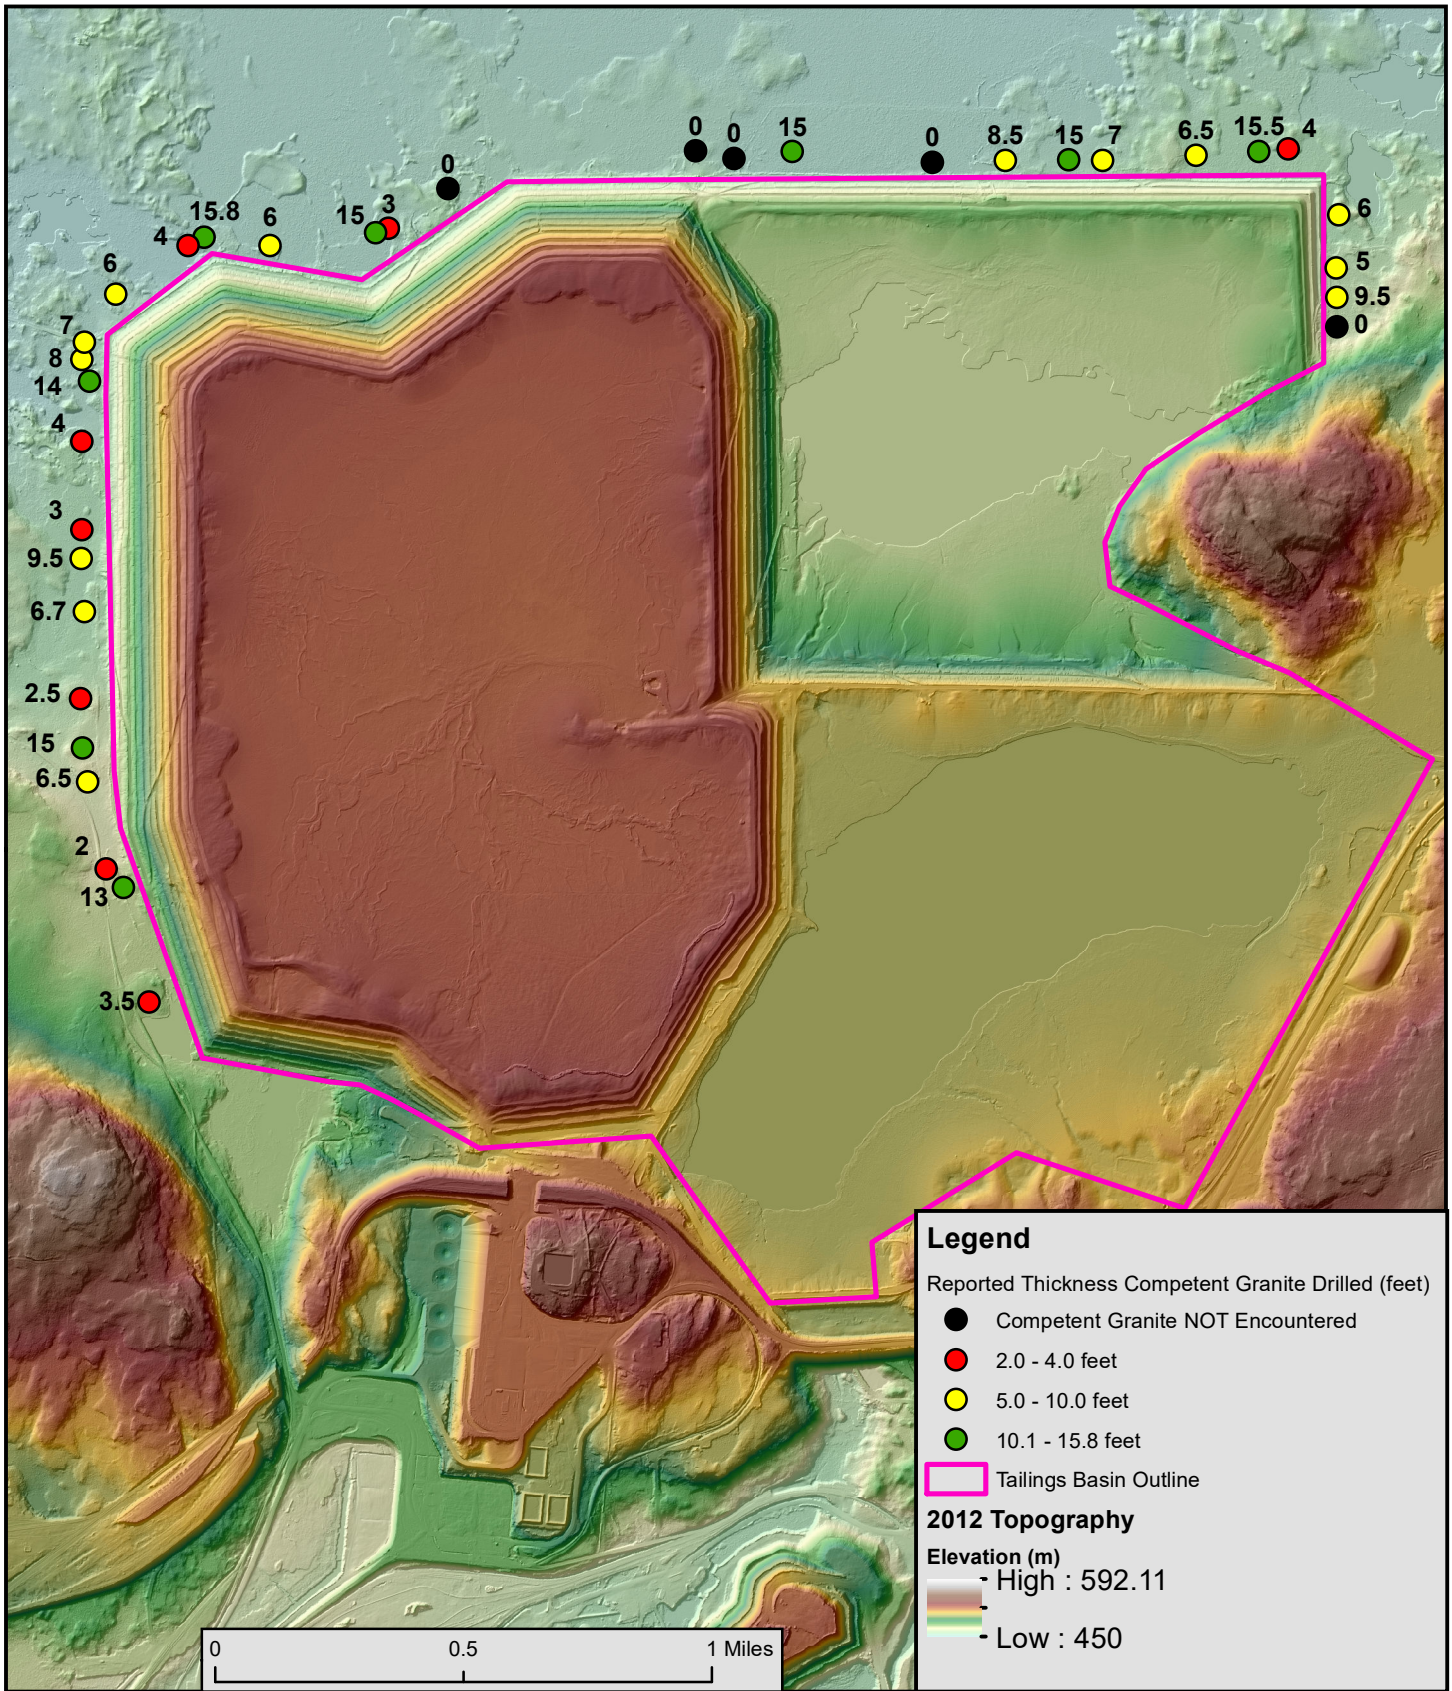
FIGURE 15. POLYMET'S REPORTED THICKNESS OF COMPETENT GRANITE DRILLED

Only 8 of the 34 holes⁵⁸ drilled intersected more than 10 feet of reportedly competent bedrock - the green markers shown on Figure 15. All of the remaining 26 drill holes – the black, red, and yellow markers on Figure 15 – intersected less than 10 feet of bedrock and therefore do not provide sufficient confidence that competent bedrock was reached during drilling at those locations.

In addition to the 5 drill holes where no competent granite was encountered (the black markers on Figure 15), 8 additional drill holes (the red markers on Figure 15)⁵⁹ only penetrated 2 to 4 feet of reportedly competent granite before stopping (Table 1 and Figure 15). The depths to competent bedrock reported in these areas should be considered highly suspect since the commonplace occurrence of large boulders of at least 4 feet in diameter increases the likelihood that at least some of these holes were terminated on boulders instead of competent bedrock.

⁵⁸ Seven holes confidently intersected > 10 feet of reportedly competent bedrock: B14-36, 40, 48, 52, 55, 65 and 76. B14-72 showed inconclusive results whether competent granite was reached. It is mapped competent on Figure 15.

In summary, 22 of the 34 drill holes in PolyMet’s dataset (65%) either did not encounter any competent bedrock at all or only reported 7 feet or less of sound bedrock and 26 of the 34 drill holes (76%) encountered less than 10 feet of sound bedrock (Table 1, Table 2, and Figure 15). As shown in Figure 15, this results in a gap along the north boundary of the tailings basin of nearly one and a half miles where only a single drill hole⁶¹ confidently defines the depth to competent bedrock along the proposed slurry wall alignment (Figure 15).

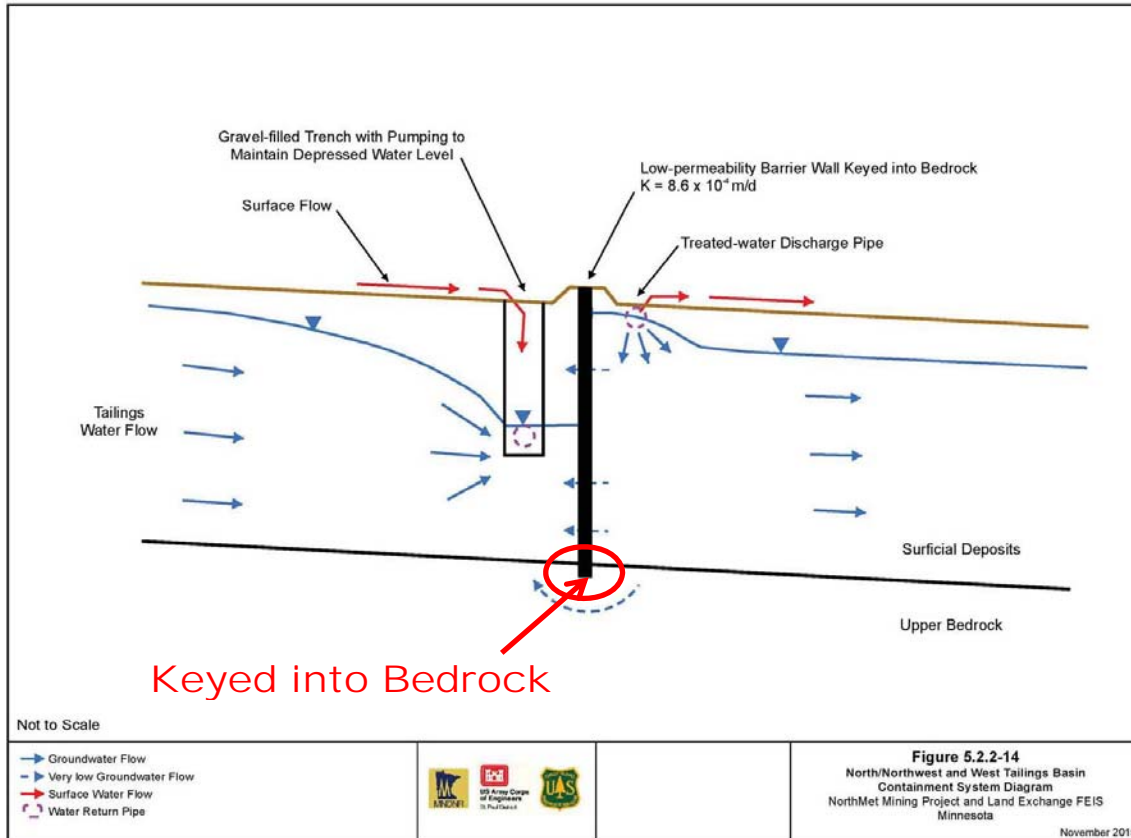
In order for the slurry wall to meet permitting conditions and claimed pollution control efficacies it must be constructed so that it is “keyed to competent bedrock.” However no explanation is provided of how the bentonite slurry wall will be “keyed to competent bedrock” at great and still uncertain depths and into solid granite bedrock. This is not a detail that can be left to future “adaptive management” if difficulties are encountered during construction or the seepage collection system fails to perform. If the bentonite slurry wall is not properly keyed into bedrock (Figure 16), larger-than-predicted volumes of untreated groundwater seepage will pass beneath the slurry wall, bypassing capture by the pumping network and adversely affecting the environment.

FIGURE 16. DRAWING SHOWING SLURRY WALL “KEYED TO COMPETENT BEDROCK” Source: Final EIS, p. 1068. Note: the original drawing from the Final EIS has been modified here by adding in red the explanation of the “keyed into bedrock” relationship that the original drawing shows but does not label.

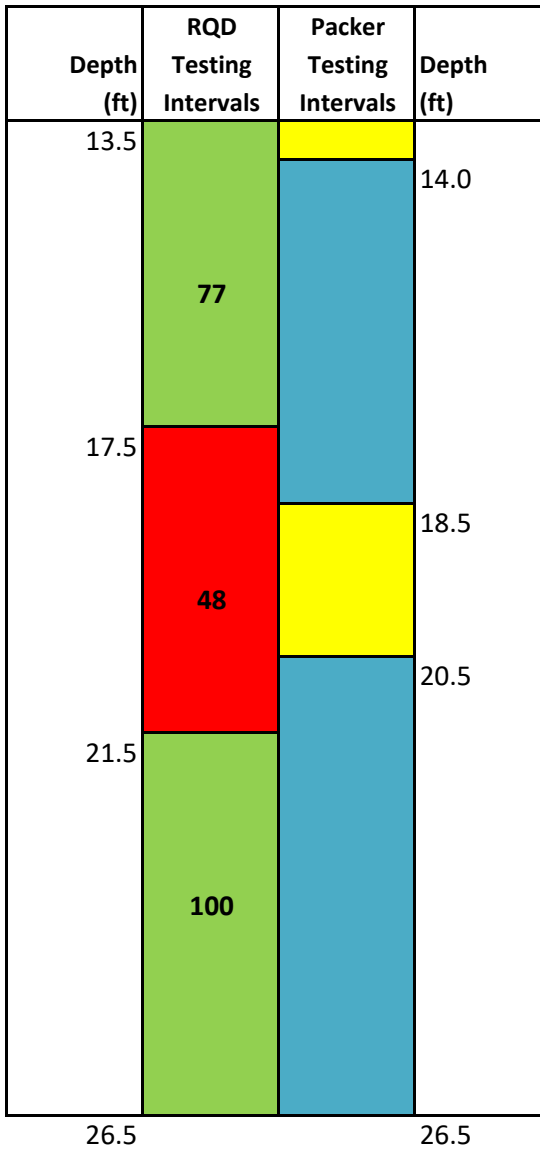
Drill Hole B14-36

GRANITE REPORTED AT 13.5 FEET

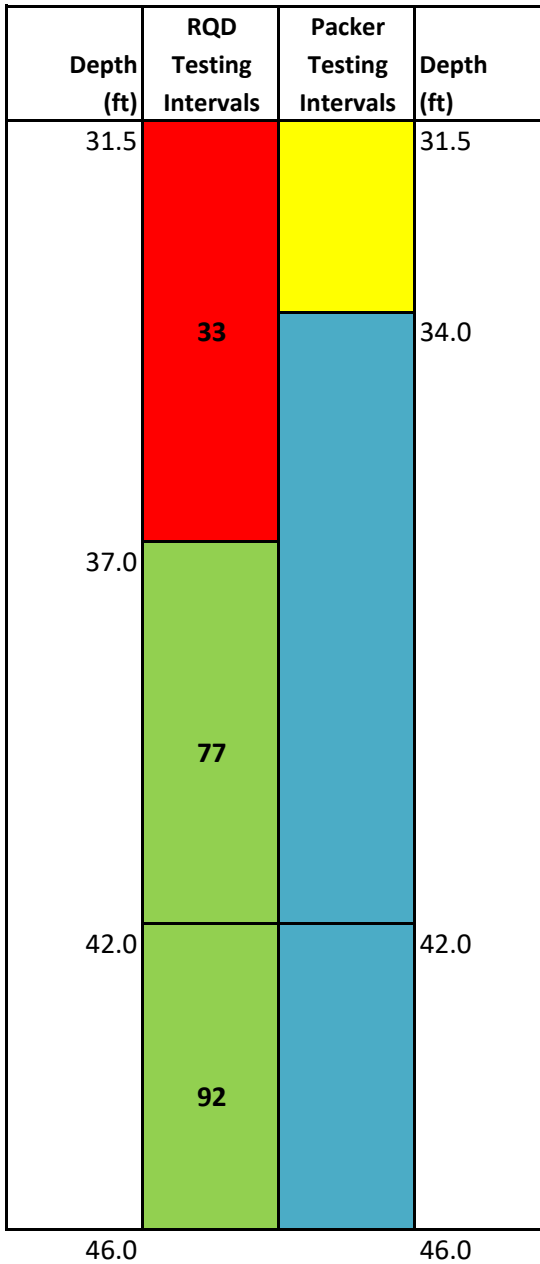
Drill Hole B14-44

WEATHERED GRANITE REPORTED AT 31.5 FEET

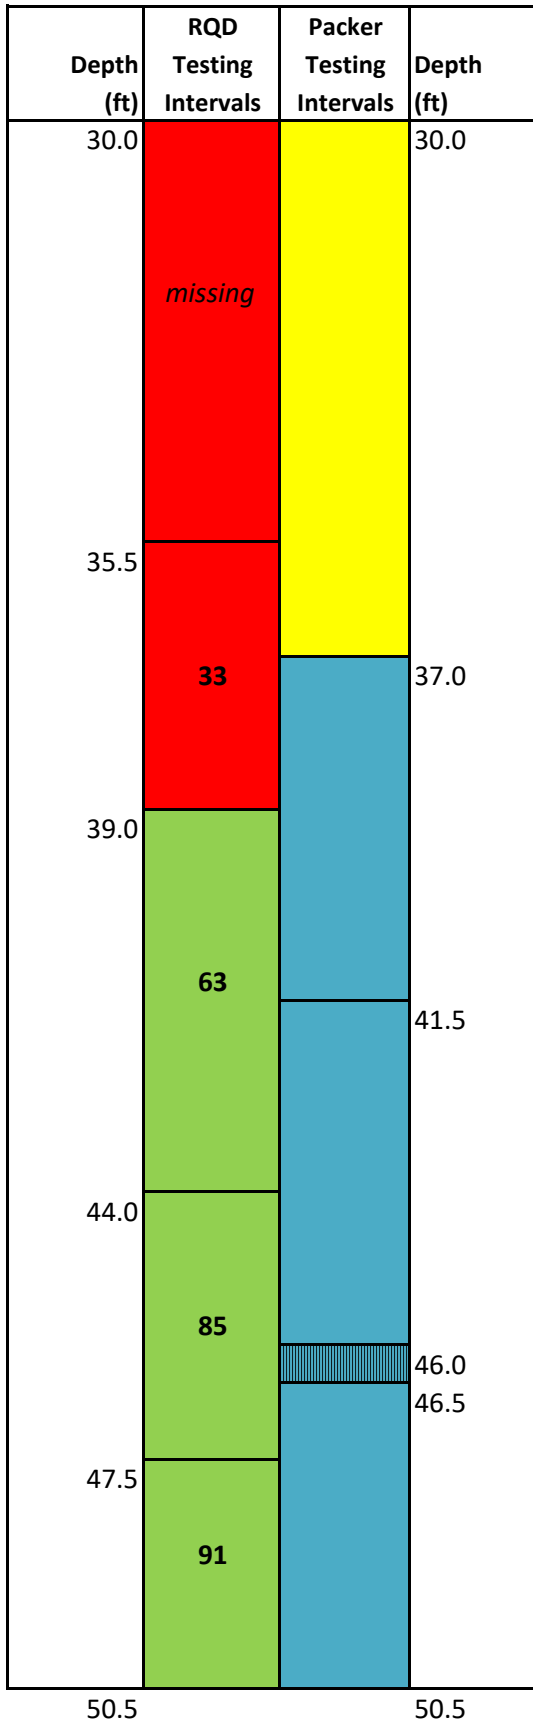
Drill Hole B14-55

GRANITE REPORTED AT 30 FEET

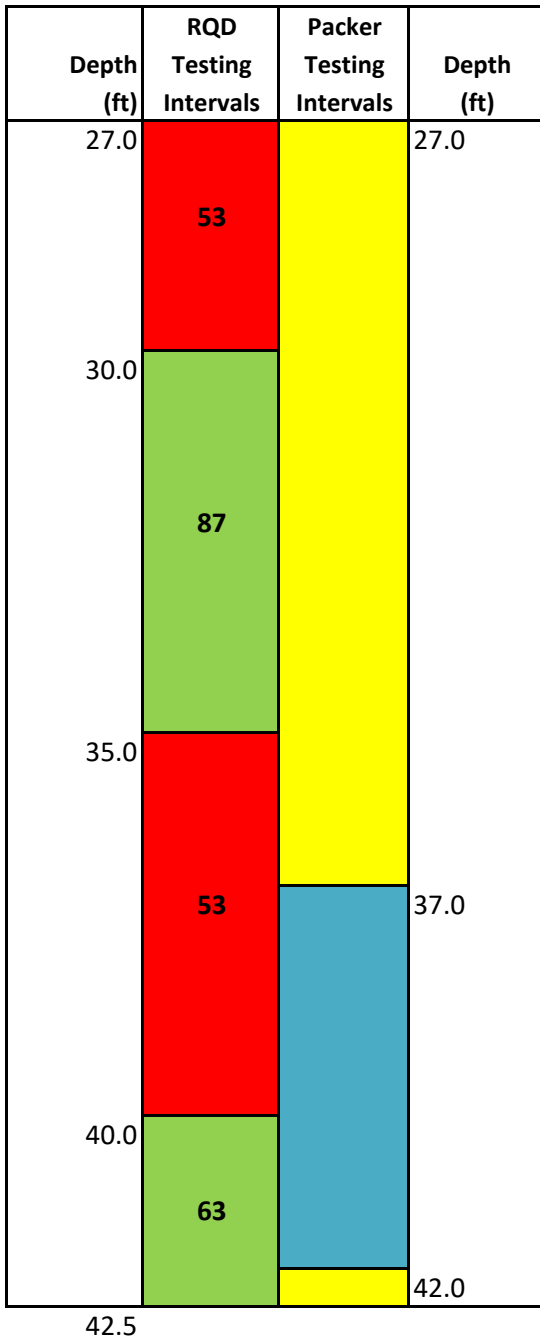
Drill Hole B14-76

GRANITE REPORTED AT 27 FEET
